Test to Failure of 3/8-Inch Tube Ferrule Connections in an Effort to Determine the Shear Strength of a Varying Number of Threads Engaged

# Test Objectives

- Determine maximum pressure loads on 3/8-inch tube ferrule connections for a varying number of threads engaged in an effort to determine the shear strength of those threads engaged

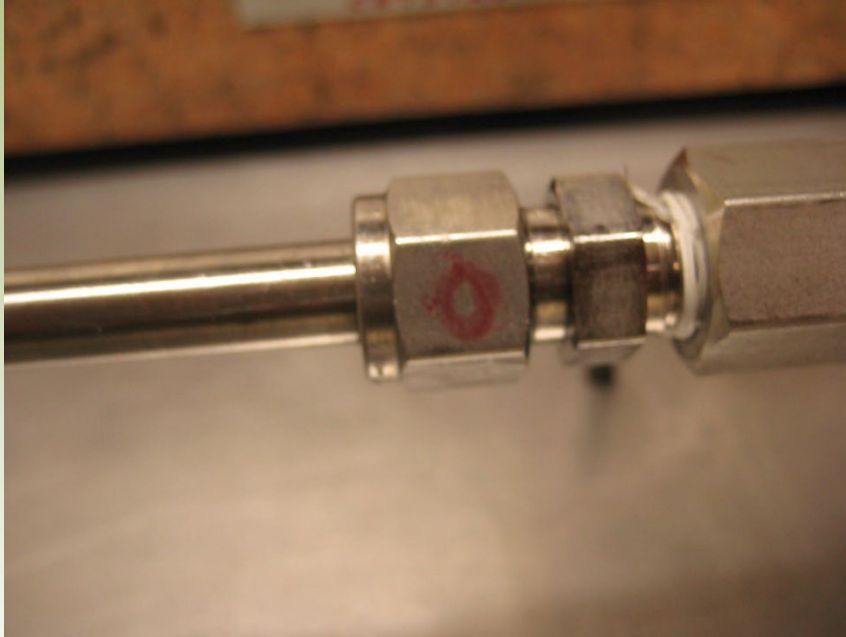
Assembled Test Connection (Typical) Prior to Pressure Test

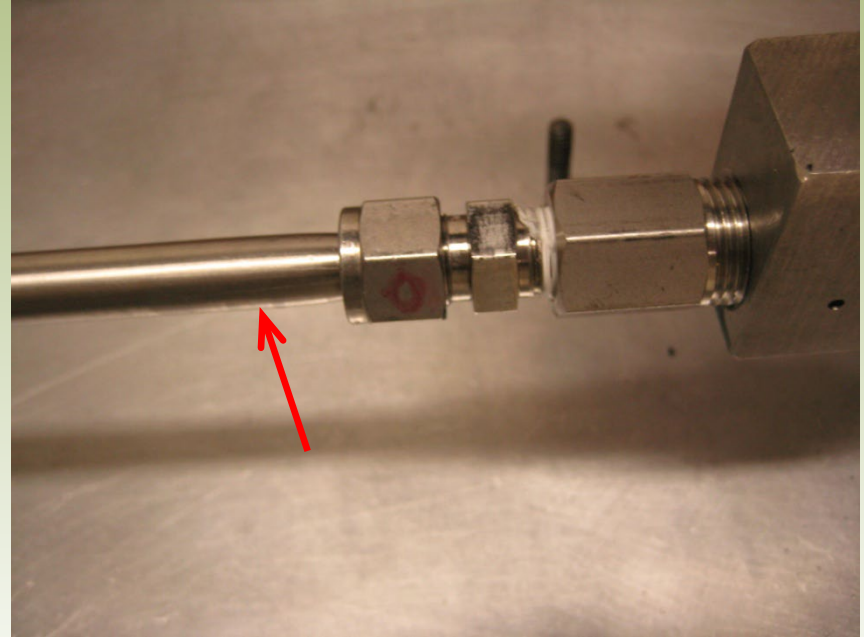
Test Connection Following Pressure Test  
(Note tube swelling due to applied pressure 4.5x tube's pressure rating)

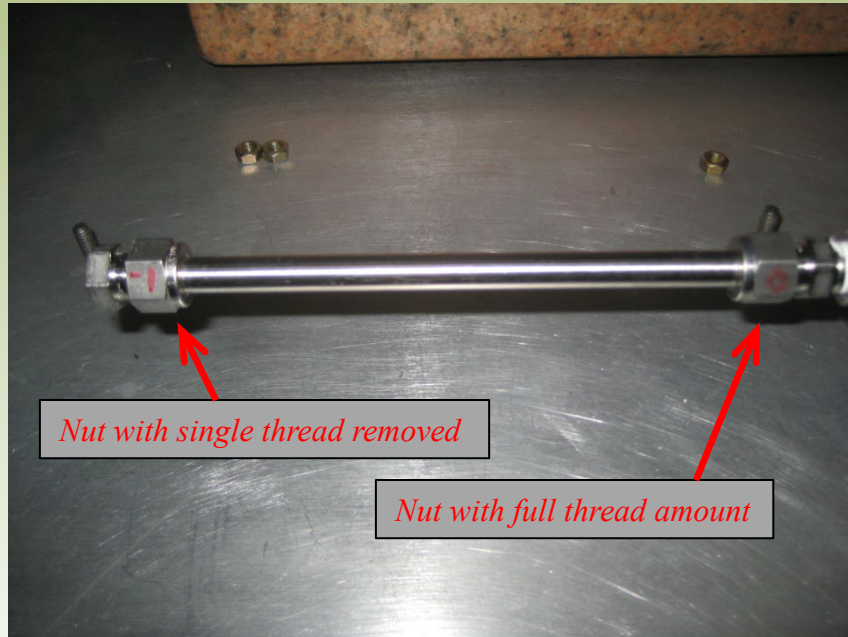
Assembled Test Connection Prior to Pressure Test

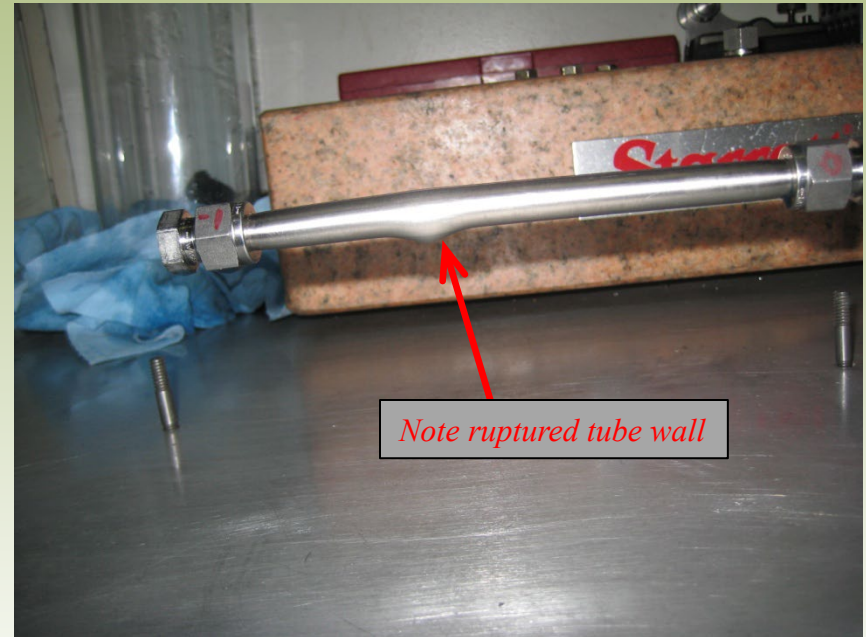
Test Connection Following Pressure Test (Tube burst at 15,000 psig, no fitting leaks observed)

Thread removed by turning pre-swaged assembled fitting on engine lathe. Following turning, the nut was tapped using KnechtionRepair tools and the fitting and nut reassembled per Swagelok recommendations.

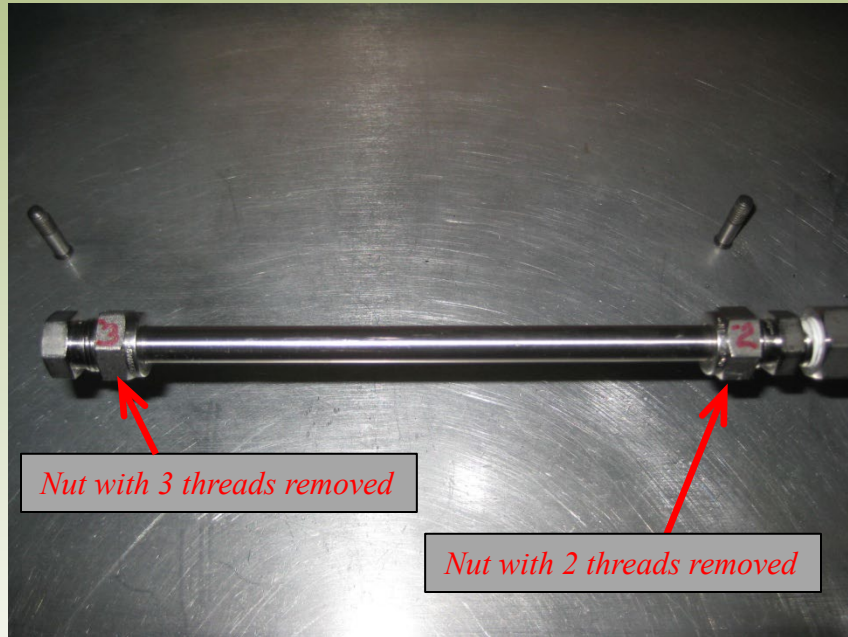
Assembled Test Connection (Typical) Prior to Pressure Test

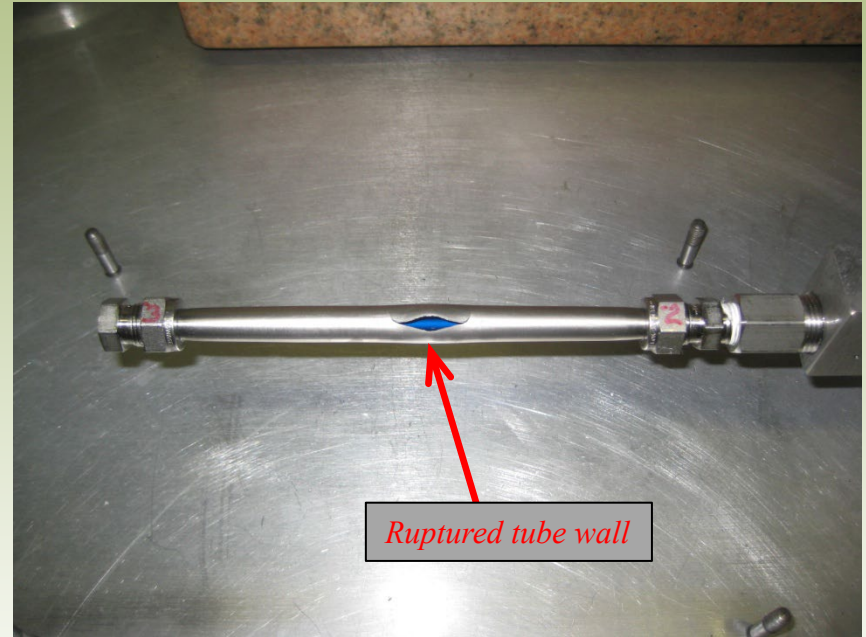
Test Connection Following Pressure Test (Tube burst at 15,000 psig, no fitting leaks observed)

Threads were removed by turning pre-swaged assembled tube fittings on engine lathe. Following turning, the nuts were tapped using KnechtionRepair tools and the fittings and nuts reassembled per Swagelok recommendations.

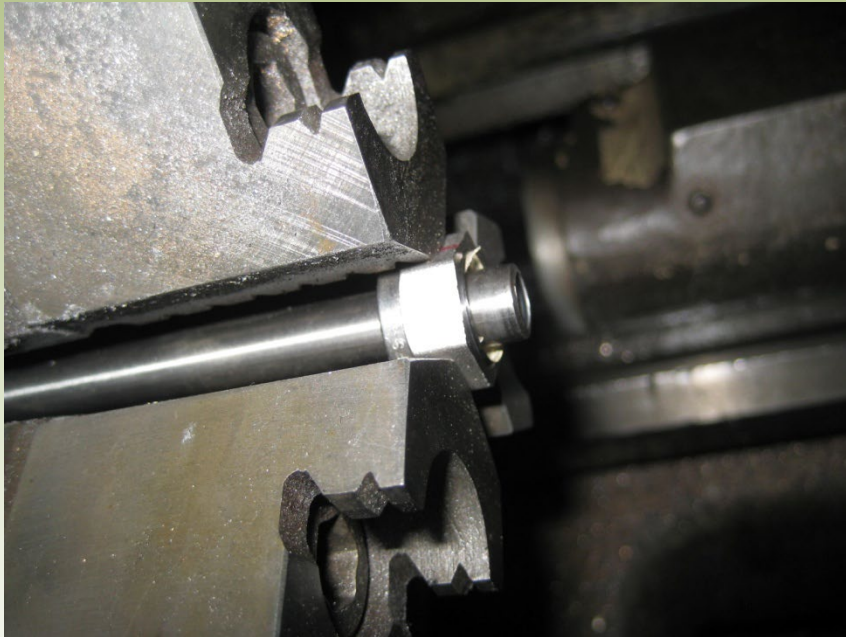
Test 3 Fitting Nut Following Thread Removal by Turning on an Engine Lathe

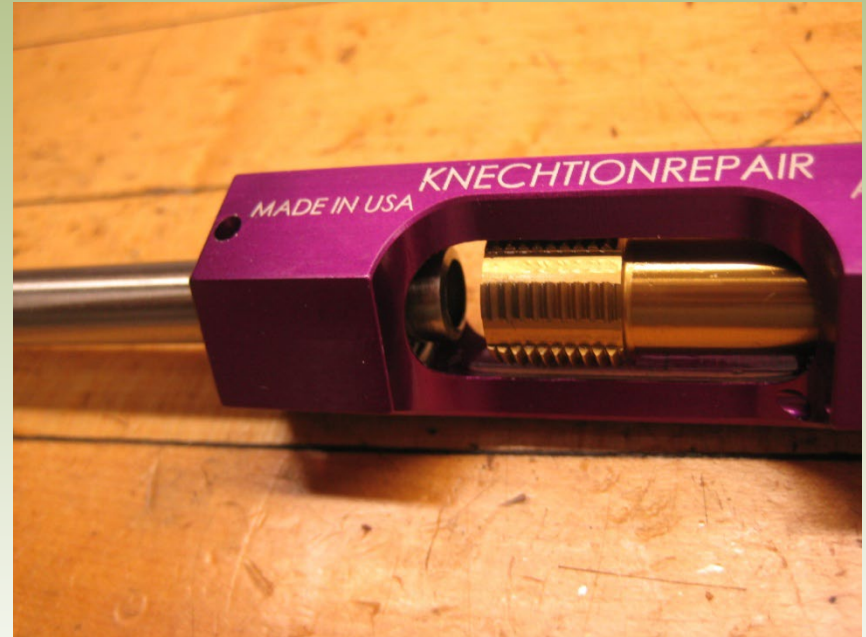
All Nuts with a Thread or Threads Removed were Tapped Following Turning using The KnechtionRepair 3/8-Inch Tap Kit

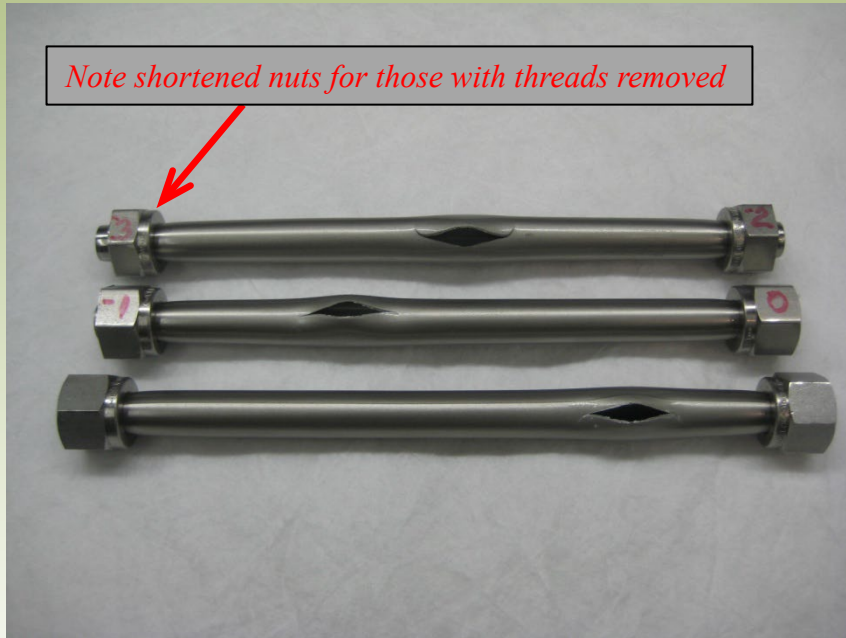
Test Articles Following Tube Burst Failure  
at 15,000 psig ( $\pm 200$  psig)

During testing there were no observed leaks or fitting failures

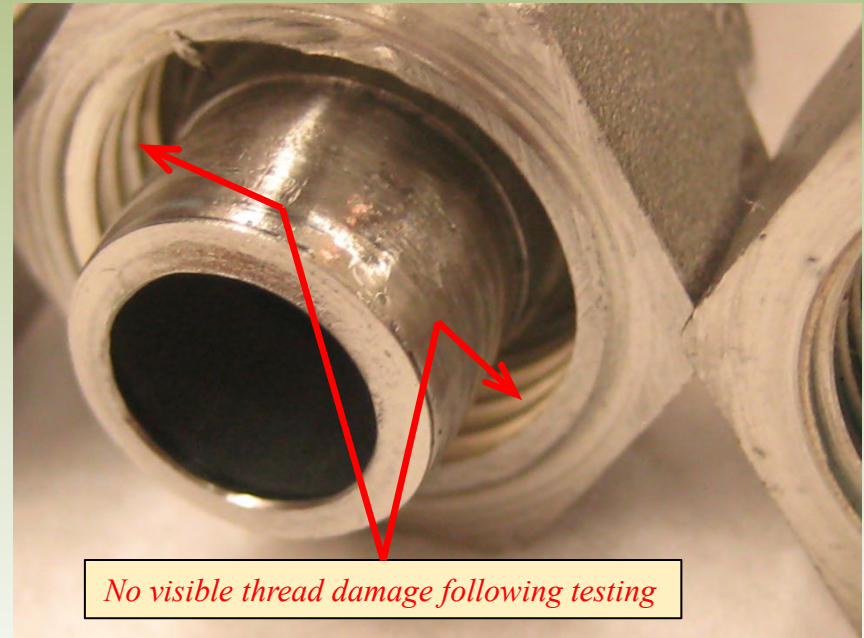
Test 3 Nut with 3 Threads Removed  
Following Testing to 15,000 psig ( $\pm 200$  psig)
