## CASE HISTORY #2

**APPLICATION:** Piping Movement Survey using Permalign® Laser Measurement System

**EQUIPMENT:** Dresser-Clark Hot Gas Expander (Turbine), 60-inch Inlet Flange

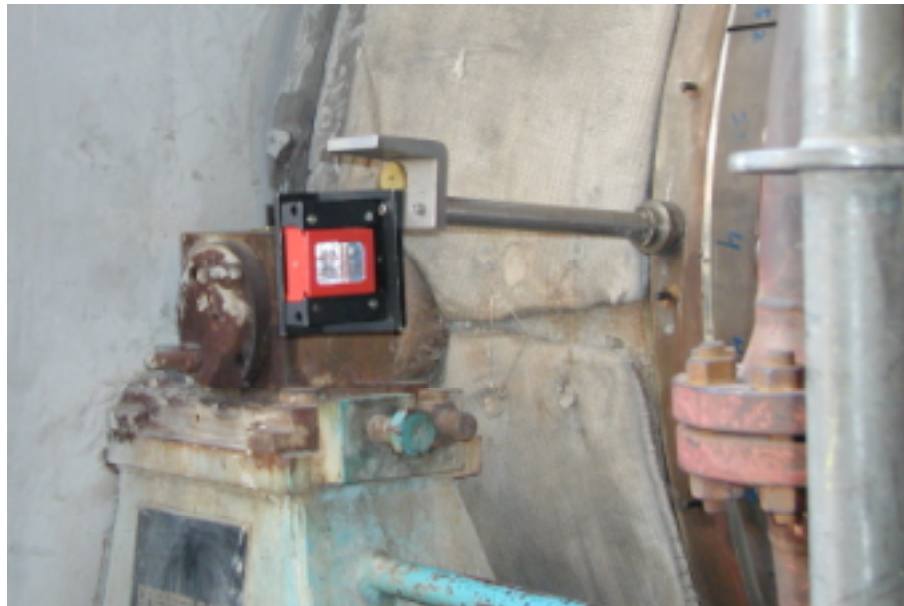
Photograph #1

### **Monitor #7, East Side, Horizontal and Axial Displacement**

Monitor Orientation: The vertical Y-axis is oriented along the machine east/west axis such that it records horizontal offset values. Plus (+) is movement toward the east and minus (-) is toward the west. Therefore the horizontal X-axis is oriented so that (+) is up and (-) is down. This axis shows displacement representing rotation about the east/west machine axis. Plus (+) values indicate rotation such that the bottom of the flange moves toward the north (toward the inlet) and the top moves to the south (toward the expander).

Prism #7, Monitors Horizontal Offset and Rotation about the east/west machine axis.

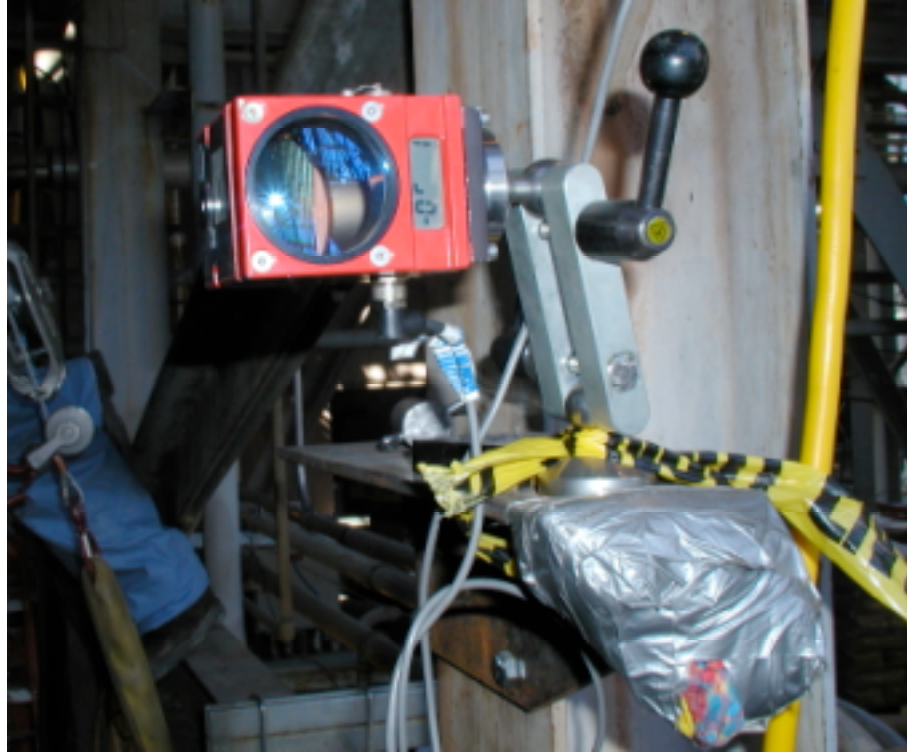
Photograph #2

Monitor #7, Records Horizontal Offset and Rotation about the east/west machine axis.

The most significant factor revealed during the static test on November 6, 2002 was the rapid progressive change in the horizontal offset reading at Monitor #7 between approximately 9:00 am and 11:30 am. Observed movement during this period was approximately  $.020''$ . Fluctuations in this position after 11:30 am were less than  $.010''$ . However, since pipe bolting and un-bolting activities occurred after 11:30 am the movement that occurred in the morning hours did not severely affect the interpretation of the movement caused by piping activity.

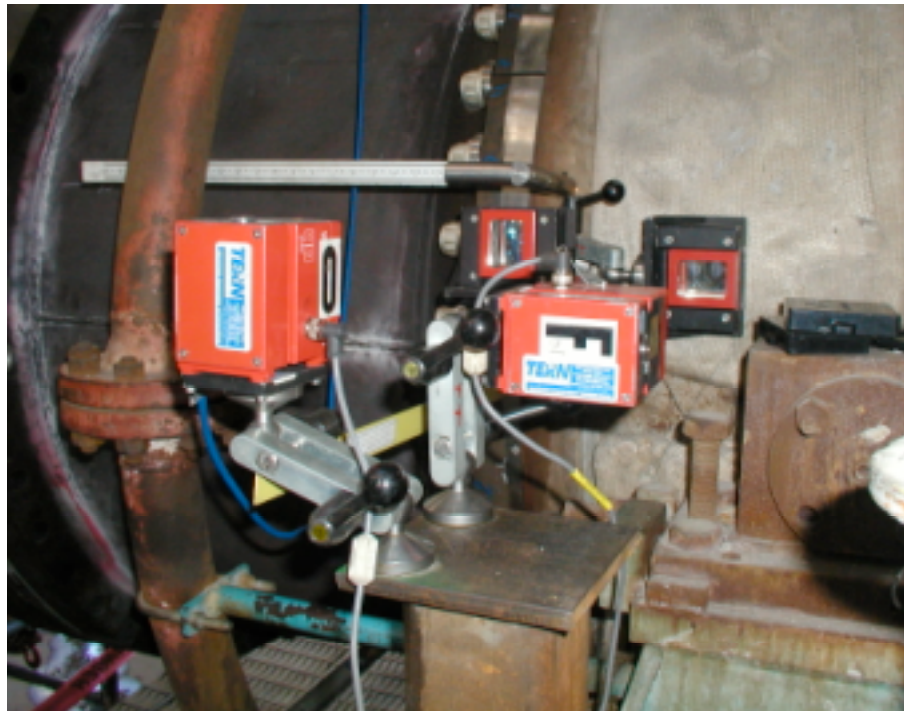
Photograph #3

Monitor Orientation: The vertical Y-axis is oriented in the normal upright position such that (+) is up and (-) is down. It records vertical offset values on the west side of the flange. The horizontal X-axis is aligned along the north/south axial axis such that (+) is toward the north, or away from the expander, and (-) is toward the south, or toward the expander. The vertical Y-axis shows vertical offset. The horizontal X-axis shows horizontal angular change, or rotation about the vertical Y-axis. Plus (+) values indicate rotation with the west side of the flange moving toward the north, or away from the expander and the east side of the flange moving toward the expander, or south.

Monitor Orientation: The vertical Y-axis is oriented along the machine north/south axial axis such that it records axial offset values on the west side for the flange. Plus (+) values represent movement toward the expander, or south, and minus (-) movement is away from the expander, or north. Therefore, the horizontal X-axis is oriented so that (+) is up and (-) is down. This axis shows vertical angular displacement or rotation about the machine north/south. Plus (+) values indicate rotation with the west side of the flange moving up relative to the east side of the flange. Minus (-) values show rotation in the opposite direction.

Monitor/Prisms #0 and #9

Monitor #0 Records Vertical Offset and Rotation about the machine vertical axis.

Monitor #9 Records Axial Offset and Rotation about the north/south machine axis.

Note: Monitor #9 is labeled #F in this photograph
